Slope stability assessment of weathered clay by using field data and computer modelling: a case study from Budapest

P. Görög and Á. Török

Budapest University of Technology and Economics, Department of Construction Materials and Engineering Geology, Stoczek u. 2., H-1111 Budapest, Hungary

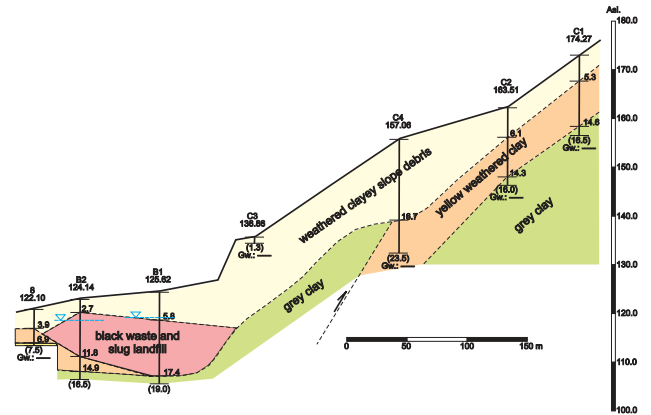
Fig. 2. The geological profile of the slope used in model calculation showing the location of drillings (borehole data from Paál, 1998).

The slope stability and factor of safety were analysed in selected sections along the slope by using Plaxis and Geo4 software. These two codes were used to model since these have different approaches to calculate slope stability. The Plaxis is one of the most widespread code works with finite elements method and capable to model complex slope morphology. It calculates the weakest point of the slope but it does not always draw a geologically feasible slip surface. Geo4 software uses conventional methods, and calculates circular slip surface by using Bishop’s method (Bishop, 1955) or polygonal slip surface applying Sarma’s method (Sarma, 1973). The slip surface can be manually entered to Geo4. It is possible to compare the circular slip surface and a similar slip surface which is calculated from vertical polygons by using this code. For the upper slope section the polygonal vertical slices (Sarma, 1973), while for the lower slope circular slip surface model was the one which provided the best results since according to borehole data the slip surface does not penetrate into the lower grey clay. The computer models were applied to draw the slip surfaces and calculate factors of safety along a section, which is shown in Fig. 2. A three-layer soil model was applied to describe slope stability features. The lowermost layer is the impermeable grey clay;

the upper layer includes both, the yellow weathered clay and clayey slope debris having very similar physical properties. The third layer, the waste landfill was only inserted in the lower slope and toe of slope part, where it is located below the slope debris. This model is in accordance with the borehole data and our field observation, that landfill is only found in a depression at the lower part of the slope (Fig. 2). The input parameters of the model were obtained from laboratory tests. The weakest measured values were used (Table 1) to have a realistic model, and to calculate the factor of safety. The stability of the clayey slope and the toe area in front of the slope were also analysed. Another aim of our analyses was to demonstrate the effect of the site development on the slope stability by using a 300 kN/m² distributed load at the top of the slope. These model conditions represent the situation when houses are built upslope.

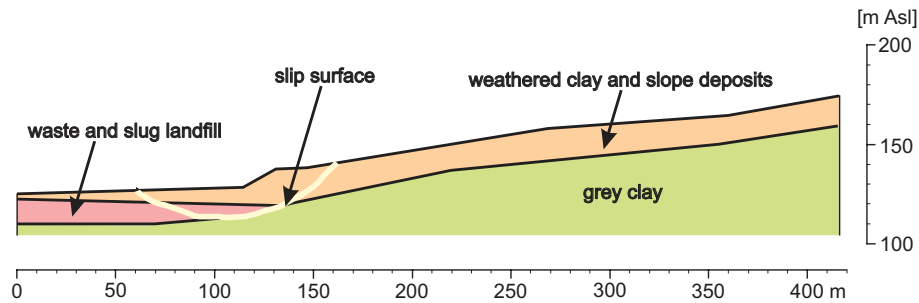
Fig. 3. The calculated circular slip surface by using Geo4 (factor of safety: $n=1.7$).

Stability of the natural slope was analysed in the first set of models. Geo4 software needs an initial slip surface as an input and the software optimise it. Namely, it searches the location of the slip surface when the safety factor is the smallest. It can both work with circle and polygonal slip surfaces. The slope can be divided into two parts since the upper part is best modelled with a two-layer model while at the lower part waste and slag landfill occurs, and thus a three-layer model was applied. At first, the weakest point of the slope was determined, where the factor of safety has a minimum value. It was found to be at the foot of the slope deposit. The circular slip surface penetrates into the waste and slag landfill when Geo4 software calculations were applied (Fig. 3). In this case the calculated factor of safety is $n=1.7$. For comparison, the same geological structure was used for finite element model calculations. The analyses with the Plaxis almost gave the same slip surface (Fig. 4) and the calculated factor of safety

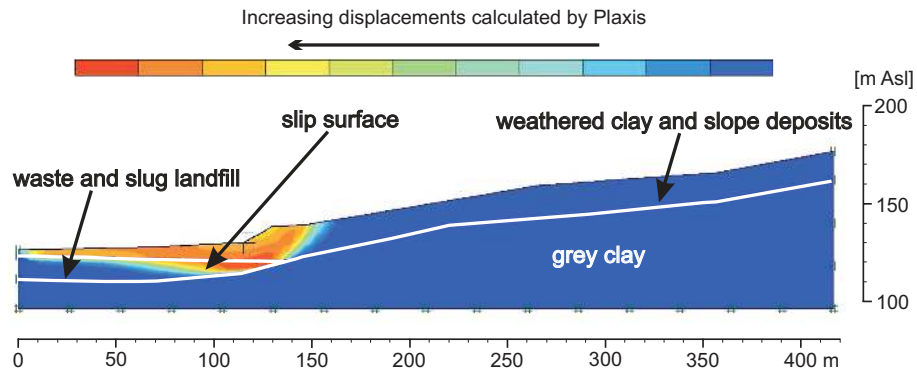
Fig. 4. Displacement distribution of the slope with surface load calculated by Plaxis (factor of safety: $n=1.6$).

is slightly less ($n=1.6$). Nevertheless, it is necessary to note that the Plaxis works with combined factor of safety. Consequently a factor of safety $n=1.6$ calculated with Plaxis is equal to a factor of safety of $n=1.7$ – 1.8 calculated with conventional method.

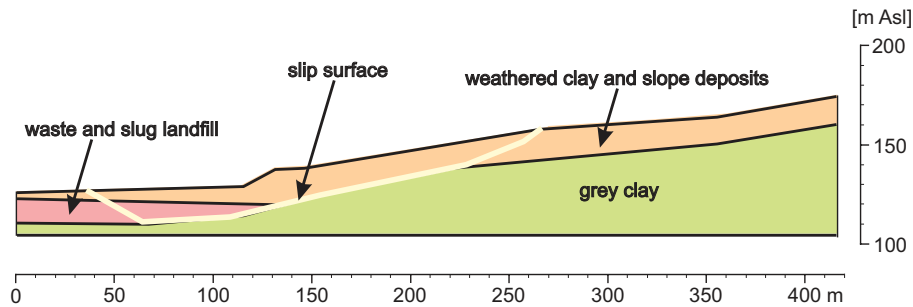
Fig. 5. The calculated polygonal slip surface by using Geo4 (factor of safety: $n=2.0$).

The supposed sliding mass was divided into n vertical slices according to Sarma (1973). It gave a polygonal slip surface which was also modelled by Geo4. A factor of global safety was also calculated with Geo4, since the global factor of safety of the slope cannot be analysed with Plaxis. It is related to the fact that in the finite elements modelling such as Plaxis the location of the slip surface can not be manually adjusted. The lower part of polygonal slip surface coincides with the circular slip surface while the upper part of it follows the boundary zone between the impermeable grey clay and the overlying weathered clay and slope debris (Fig. 5). The factor of safety with this polygonal slip surface is $n=2.0$.

The angle of friction of the weathered clay and slope debris is higher than the angle of the slope, thus the global factor of safety is higher compared to the case when the circular slip surface was modelled. For the lower part of the slope where waste and slug landfill are also present, the safety factor is smaller thus these layers cannot support the slope especially when water infiltrates. The main trigger mechanism of landslides is related to rainwater infiltration. The precipitation water infiltrates into the weathered clayey slope debris

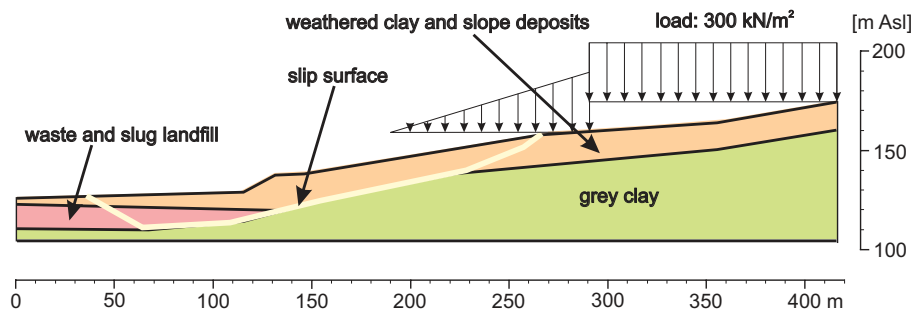
Fig. 6. The calculated polygonal slip surface for building load by using Geo4 (factor of safety: $n=1.6$).

and seeps via the yellow weathered clay down to the boundary to grey clay. In this boundary zone, where the slip surface is located, the water significantly reduces the physical parameters of both clays, by increasing pore water pressure and decreasing friction angle and cohesion. Former experiences have also shown that in similar clays (Okamoto et al., 2004), such as the yellow weathered clay, the increasing water-content radically decreases the angle of friction contributing to slope failures. According to model calculations the loads from house constructions on the upper slope have no significant influence on the safety factor when circular slip surface model is used. To the contrary it reduces the global safety of the slope to $n=1.6$, when the polygonal slip surface model is applied (Fig. 6).
